مشروع قناطر نجع حمادى الجديدة

مشكلة انهيار ميول قناة التحويل

(Study of Slope Failures During Excavation of the Diversion Canal)

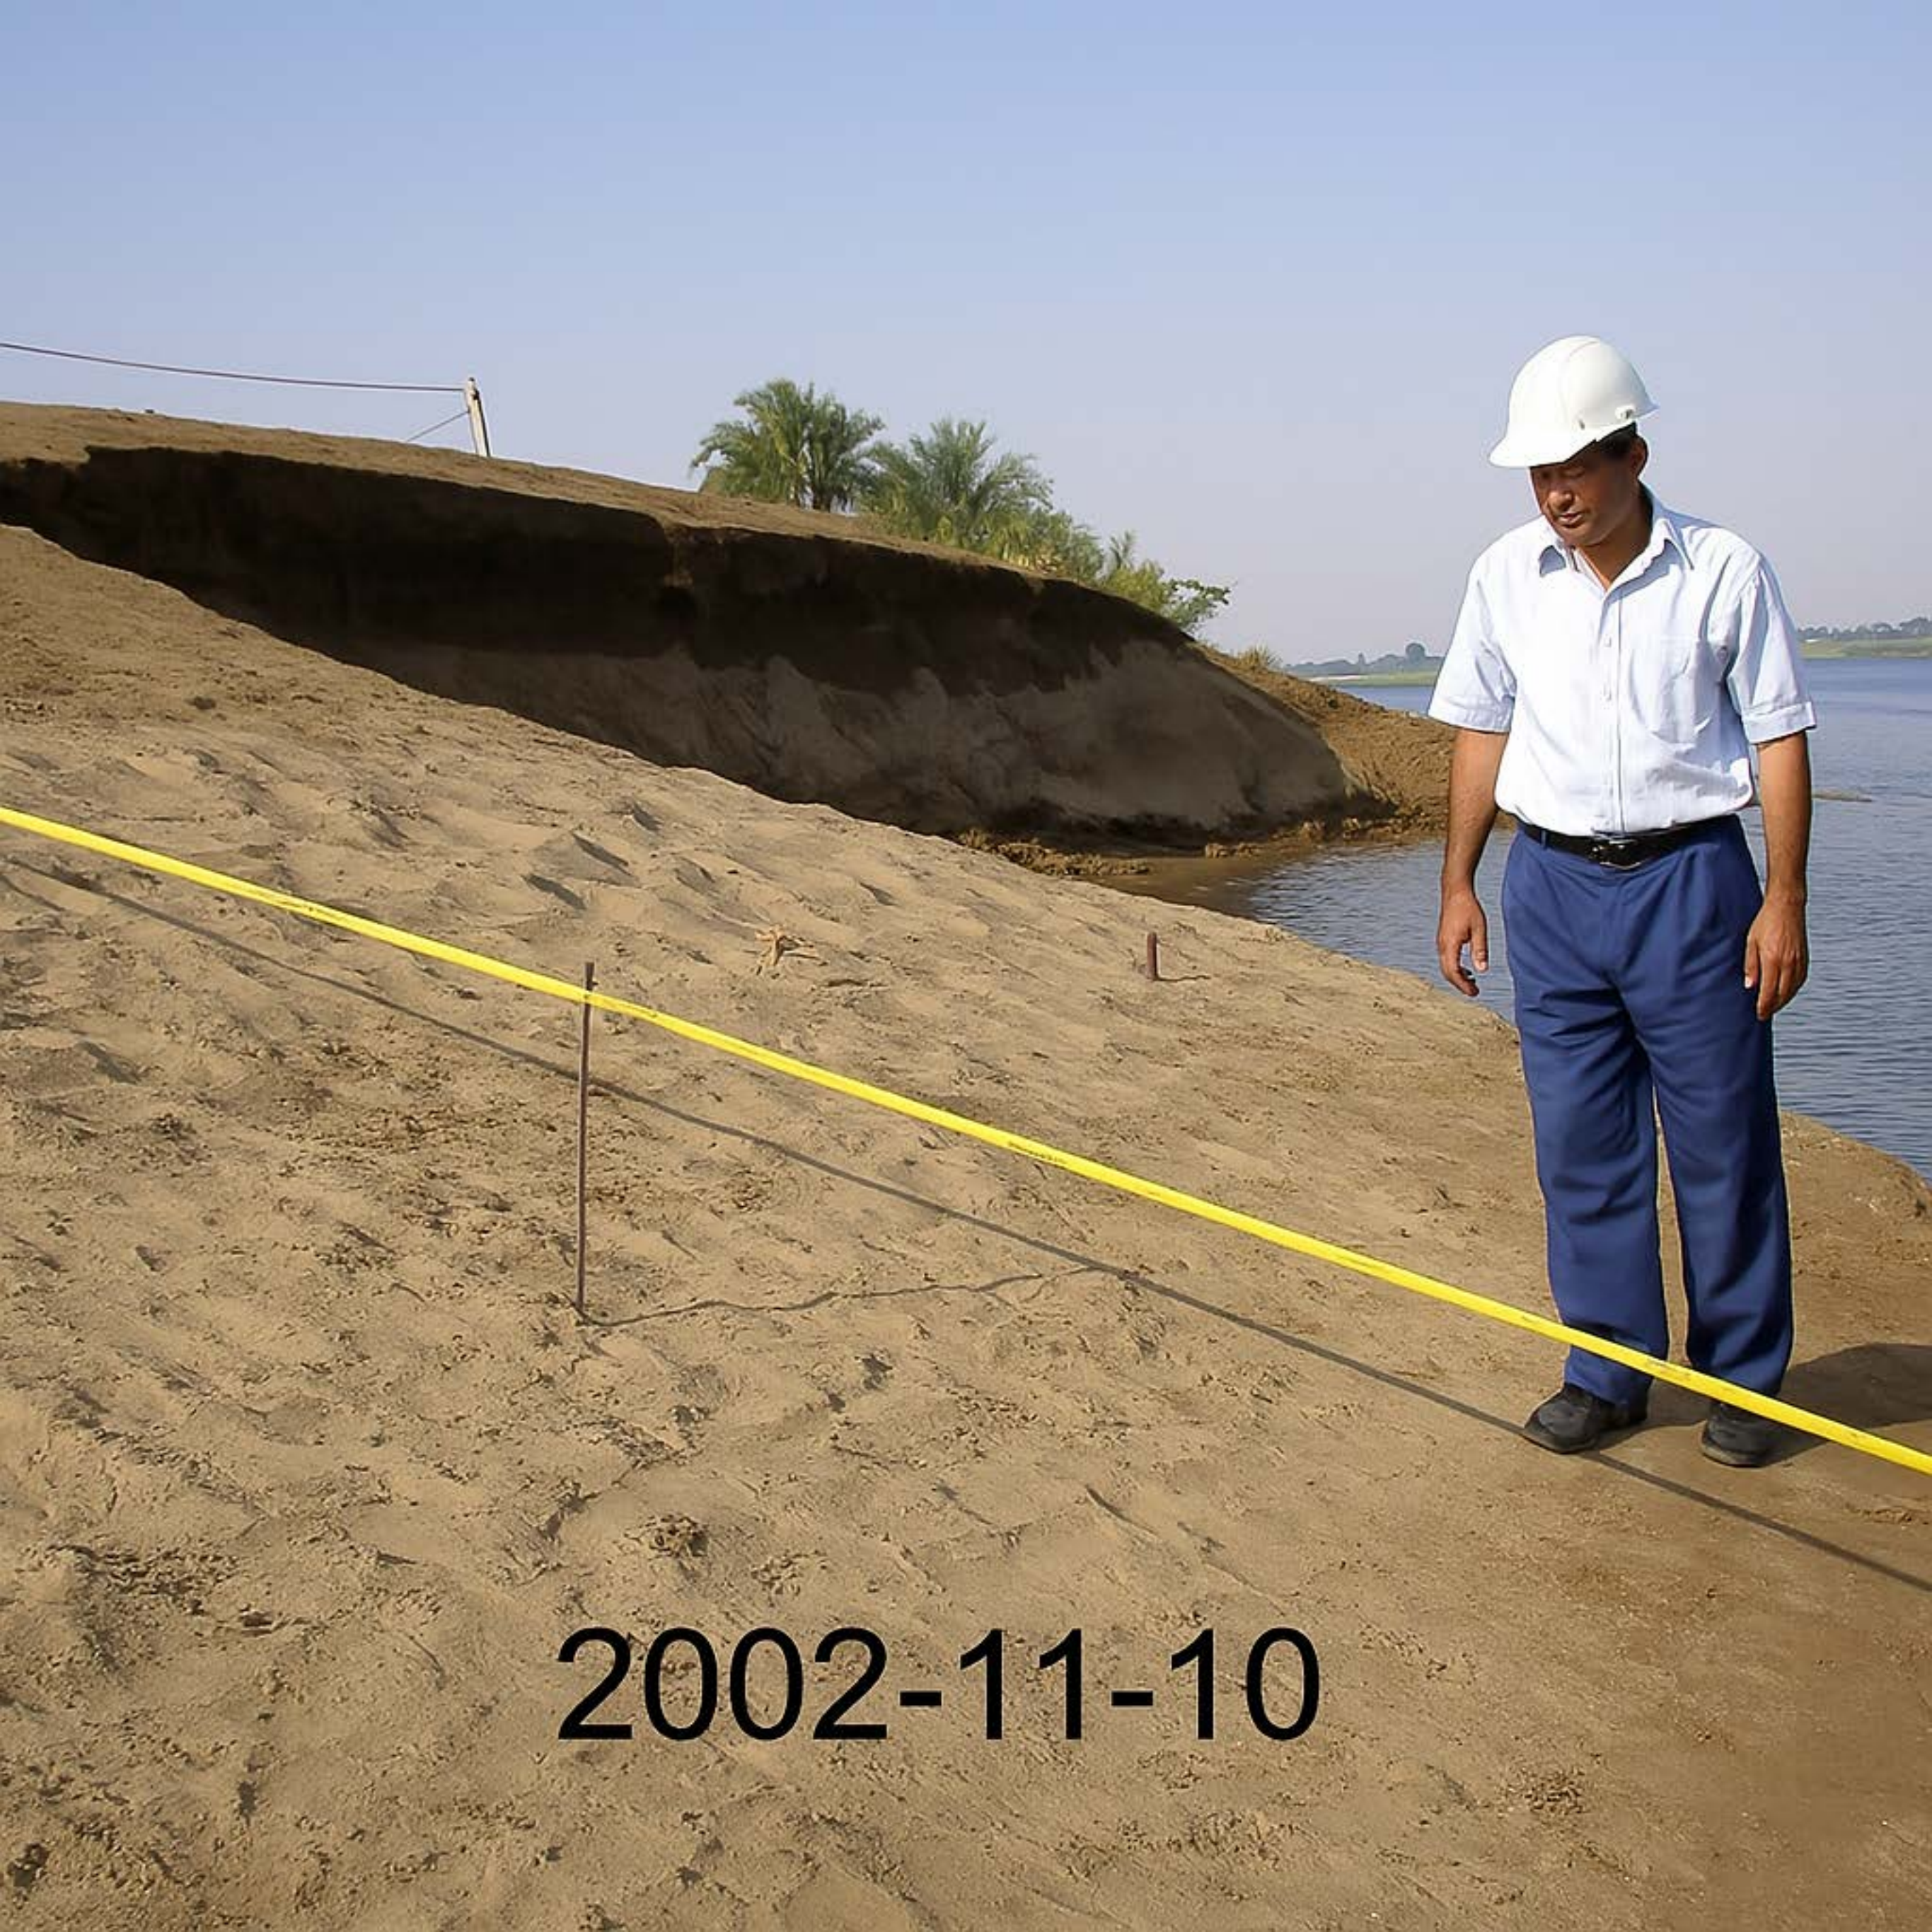
2002-11-10

- استيقظ الجميع صبيحة يوم الاحد الموافق 10 نوفمبر 2002 على انهيار كبير بالميل يالبر الأيسر فى شمال التحويلة كان شيئاً غريباً وغير متوقع الحدوث ومع ذلك استمر المقاتول فى العمل حتى فوجئ الجميع بحدوث انهيار اخر كبير فى 22 ديسمبر من نفس العام 2002 .. بدأ القلق يتسرب الى الجميع إن خطر كهذا كفيل بتأخر انتهاء الأعمال بالتحويلة وكذلك سيترتب عليه تأخر جميع الأعمال المترتبة عليه من سدود مؤقتة وأهم من ذلك المنشأ الرئيسى نفسه وهو القناطر الجديدة.

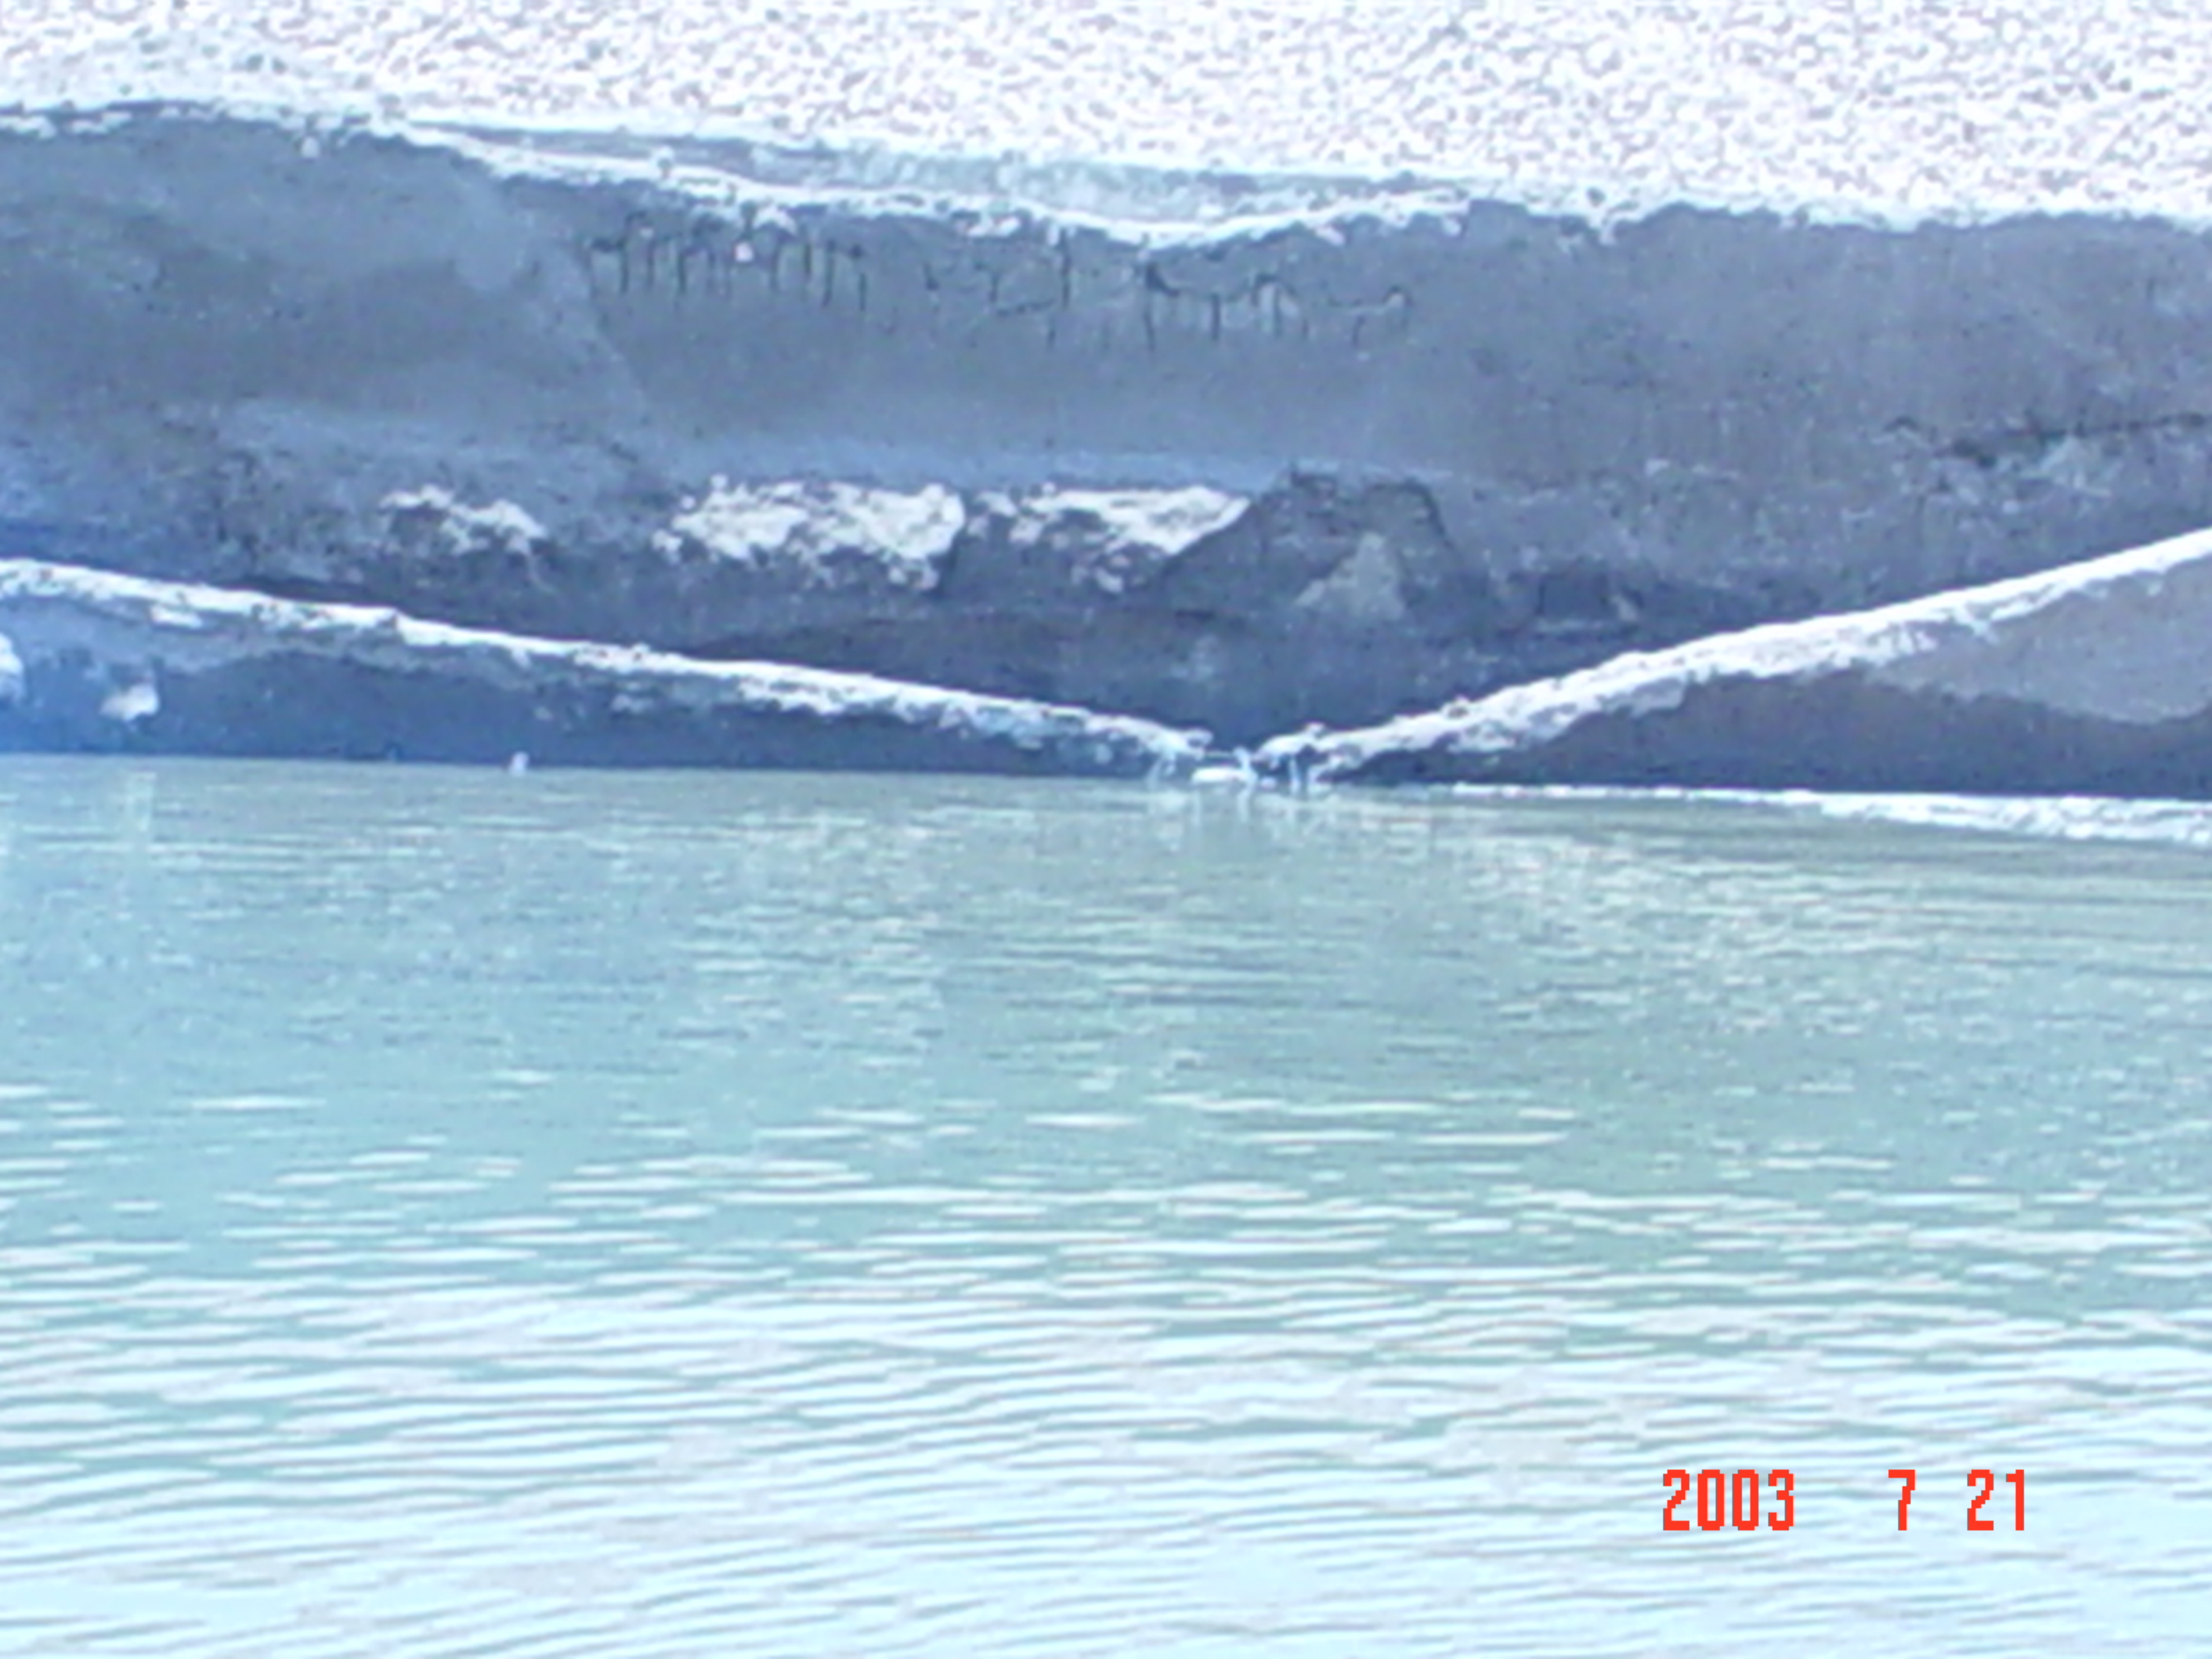
2003 7 21

- حدث الانهيار الأكبر يوم 2003-7-21 في البر الأيمن أيضا شمال الانهيار السابق ولكن أخطر حيث وصل الى الستارة المؤقتة وأصبحت مكشوفة بطول 30 مترا
- أصبح الشغل الشاغل الان هو المحافظة على سلامة الستارة واللاحق بموعد تشغيل قناة التحويل في 2003-10-30.
- في اغسطس 2003 اقترح المقاول عمل تجربة لتشكيل الجانب الرئيسي في الجزء الشمالي من قناة التحويل باستخدام حفارات ذات ذراع طويل (Long Arm) محملة على بارجة الا انها فشلت بسبب صعوبة تثبيت البارجة بدقة، مما أدى إلى حفر زائد وتشققات و قيام الاستشاري بإعطاء تعليمات للمقاول بإيقاف التجربة حيث شعر الجميع إلى أن هدف المقاول من التجربة كان إثبات أن الجرافتين وطريقة التشغيل ليستا السبب في الانزلاقات.
- كما قام المالك أيضا بالاستعانة بالأستاذ الدكتور عبد الفتاح أبو العيد لدراسة المشكلة ومعرفة الأسباب ومدى مناسبة تصميم الاستشاري وكذلك معدات التكريك وأسلوب التشغيل الذي قام به المقاول.

- 1- ابعاد الشفاط الصفا الأكبر سعة عن العمل بقرب الميول
- 2- متابعة اعمال التكريك بالليل ووضع مهندس من الاستشاري لمتابعة عمل الشفاط
- 3- تقليل الميل من 3:1 الى 5:1 وفي المخرج الشمالى للقناة يمكن زيادته الى 7:1
- 4- العمل في هذه المنطقة بالحفارات ذات الزراع الطويل long arm
- 5- سرعة ردم المناطق المنهارة وحمايتها بالاحجار RIP-RAP

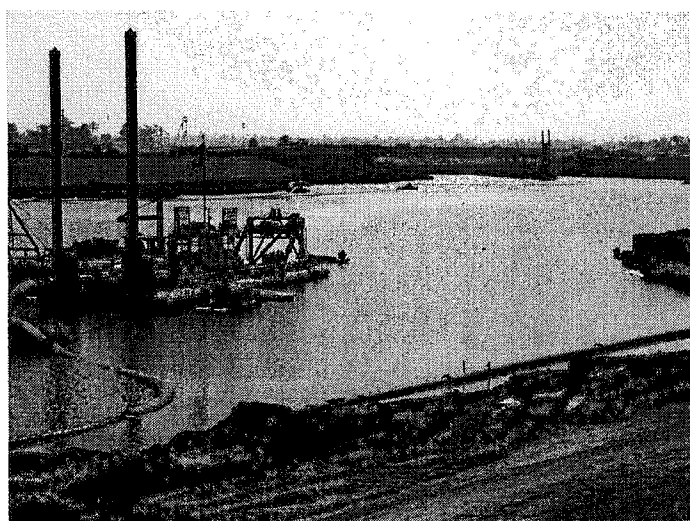
**fig. 1: CSDs El Marwa (left) and El Safa (right) dredging the diversion canal**

The CSDs seem to be in acceptable condition. The auxiliary floating equipment, too, seems to be in reasonable condition. Additional connectable floating pontoons have been mobilised to the site on Jan 23rd, 2003. Apparently they are old. The hull is covered by molluscs. NHBDC is advised to collect the proof of stability from the contractor under aspect of safety reasons.

**Remarks:** The CSD's design is old fashioned and due to the spud system used (s. fig. 1: spud stepping instead of advancing CSD via spud carriage with both spuds in CSD's C/L) they are less suitable, for slope dredging may be even unsuitable considering prevailing work conditions (for example regarding cut design, suction pipe mouth, pump force) .

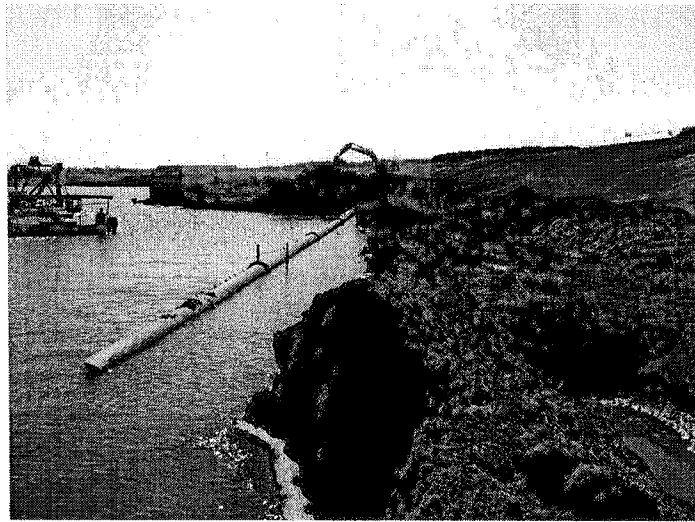
Dredging the required slope includes overdredging. This overdredging, however, would create a slope failure of the embankment so far constructed, as the already finished area above elevation 59 will be undercut.

**fig. 2: method and result of slope trial dredging**  
(demonstrating the volumes for final dredging of slope prior to embankment protection works)

**Conclusion:** The contractor shall revise his method statement especially regarding slope dredging, explain and demonstrate the different steps in detail and shall comment the consequences regarding the volumes to be dredged as well as impacts on time schedule and shall inform NHBDC without any further delay.

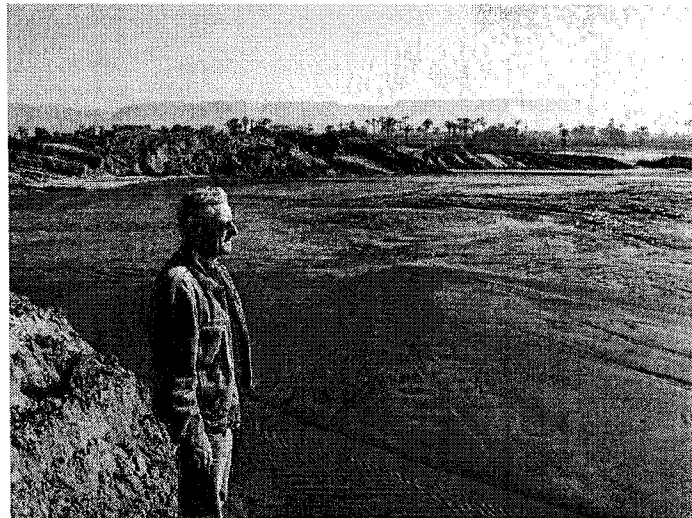
The kind of operation of the reclamation area is rather peculiar and definitely not in coincidence with the state of the art of dredging and reclamation works. Consequently to the work method the time schedule might be affected.

**fig. 3: irregular reclamation with submerged discharge pipe outlet**  
**Positioning and work control**

**Conclusion:** The contractor shall organize the reclamation area in accordance with the state of the art and contract conditions.

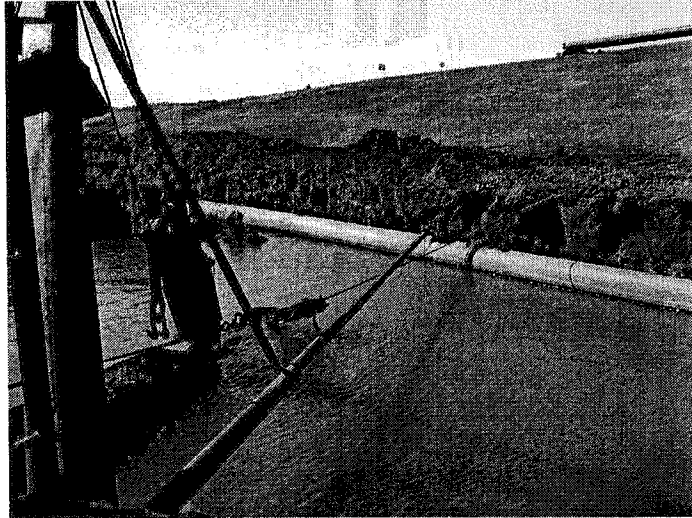
**fig. 4: positioning of cutter at cut between elevation 59 and 57**  
(floating line marks border line at elevation 57, small beam indicates cutterhead position)

The CSDs positioning system is antique and completely unsatisfying. VP recommended and explained to the contractor a modern method of dredge control, allowing on-line control of the works on board as well as in office. Under prevailing conditions NHBDC in VP's opinion definitely needs a even on-line documentation of the dredging works under execution. Otherwise a prove of quality is not possible.

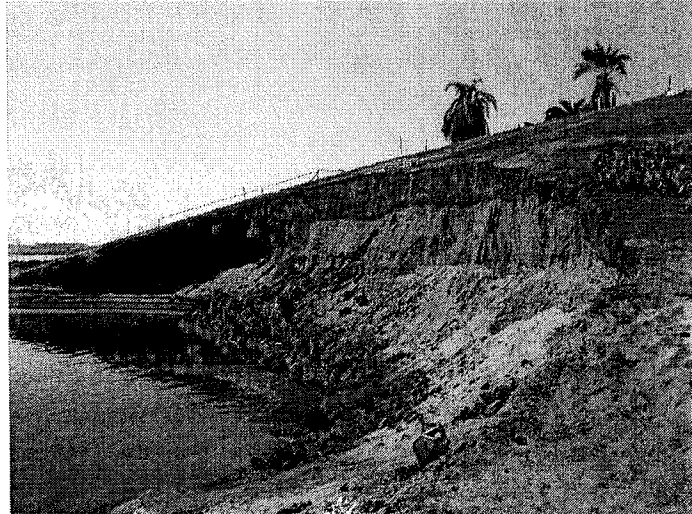
**fig. 5: slope failure #1 at northern entrance of canal**

NHBDC's calculations result in safety factors of  $h=1,41$  til  $h= 1,81$ , depending on the load combination assumed (s. Tender design report Vol.1 of September 2000). The safety factor of slope stability of  $h = 1,4$ , to be applied for normal load cases must be exceeded, what happened in all load combination cases analysed.

The slope in VP's opinion and experience in principle can be dredged with an inclination  $1:3 = H:L$  in case an adapted dredge programme is executed. A detailed soil investigation is considered necessary to get more information on the layer's location and variation. Once the final work method is elaborated, it might be revealed that the contractor does not stick to the requirements during execution. NHBDC must be able to control contractor's work.

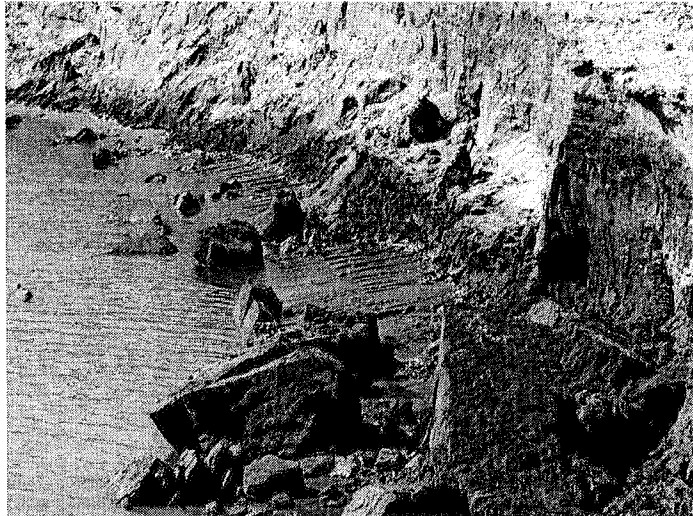
**fig 6: soil to dredged (at slope failure #2)**

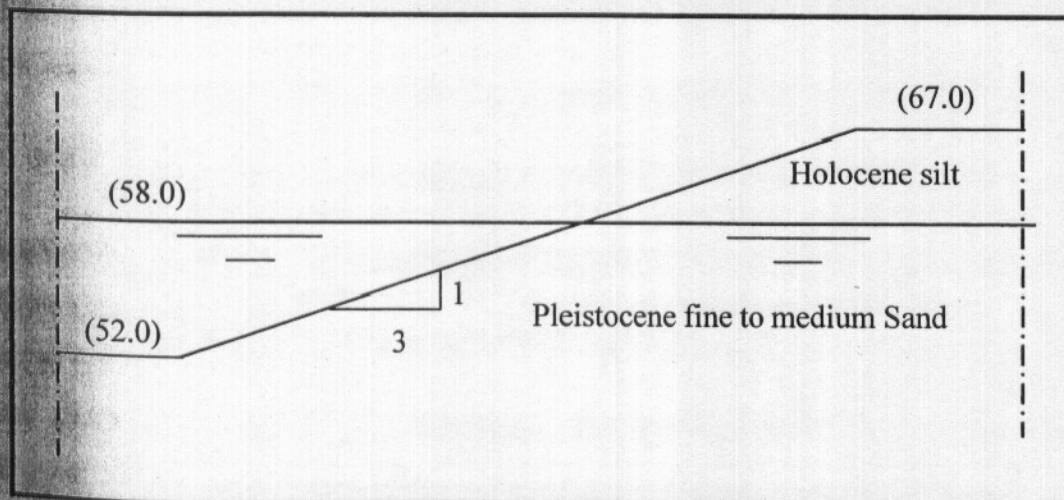
Figure 1: Typical cross section in the diversion canal slope

General experiences as well as simple calculations suggest that a 3H: 1V slope in loose to medium sands is a safe slope with adequate margin of safety under hydrostatic conditions. Assuming no lateral seepage through the investigated slope, two scenarios were found possible, in principal, to cause the reported failures. The first is the undercutting in the bottom sandy part of the slope, presumably due to over-dredging. The second is the loss of soil strength due to the effect of the suction pressure generated by the dredgers. Whereas the first scenario is less likely to happen, if proper operation and monitoring of dredging process is maintained, the second seems inevitable, as the hydraulic effects caused by the dredger's suction pressure cannot be avoided. Accordingly, our analysis has focused on the potential impact of suction on slope stability.
